Effective Monitoring and Adaptive Management Plans Tied to Amending Procedures in Environmental Assessment Procedures

Case Study: Toronto-York Spadina Subway Extension Project

Beth Williston, Associate Director, EA Planning - TRCA Manirul Islam, Program Manager, Mitigation & Monitoring -TRCA

October 17, 2018

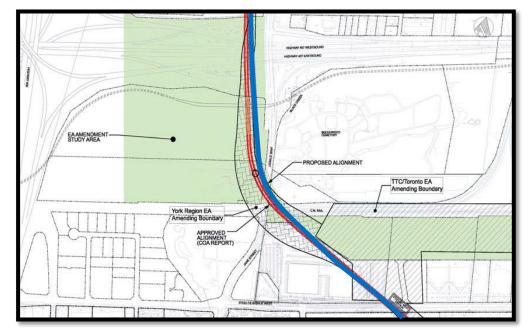
EA AMENDMENT – HYDRO TOWER 158 AVOIDANCE

- Alignment Passed Directly Underneath the Hydro Tower 158 (500KV) Foundation
- Posed a Major Technical Risk
- HONI Approval Risk
- Deeper 407 Station Box

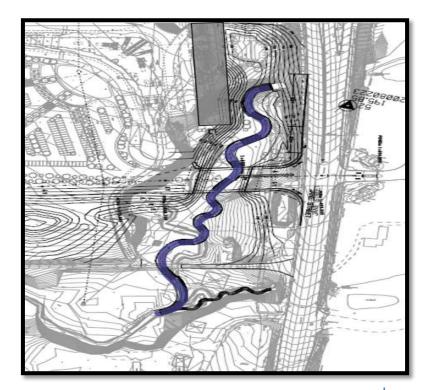
EA AMENDMENT

- Eastward Shift of Tunnel Alignment
- Eastward Shift of 407 Station Box
- Realignment of the Black Creek

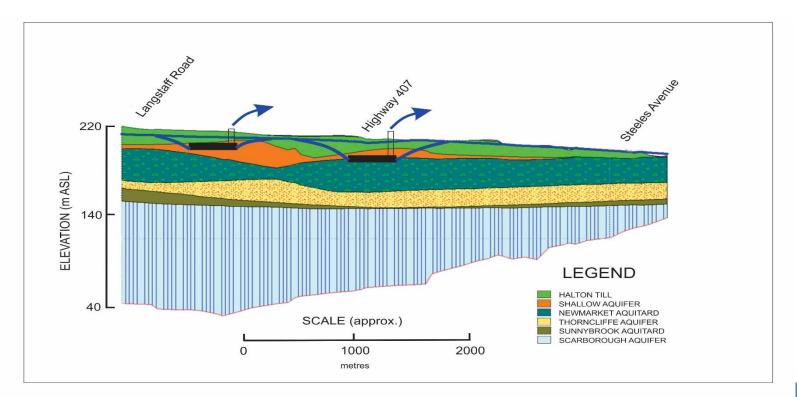
GEOLOGICAL FORMATION AT 407 AND VMC STATIONS

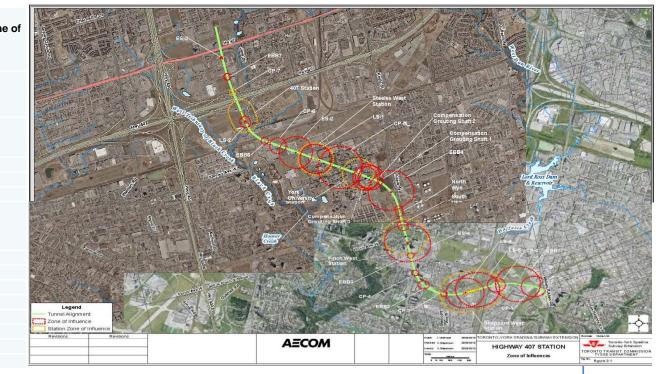
DEWATERING: ESTIMATED ZONE OF INFLUENCE (ZOI)

Site	Estimated Zone Influence
	(m)
South Wye (DEPTHS)	70
North Wye (DEPTHS and ES1)	50
EEB4	350
CP5	350
LS1	225
Steeles West Station (incl. cross-over tracks, ES2, and EEB5)	265
CP6	130
EEB6	<50
LS2	70
407 Stn	70-190
LS3	70
CP7	<50
EEB7	<50
ES3	20

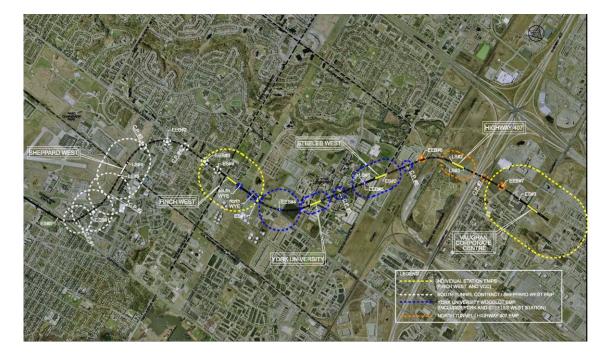
ESTIMATED ZONE OF INFLUENCE (ZOI)

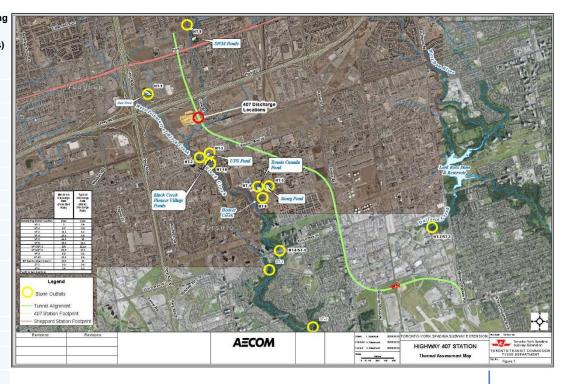
GROUNDWATER DISCHARGE LOCATIONS

Outfall Location	Receiver	Stormwater Pond Discharged Into (if applicable)	Initial Dewaterin Rate –Permitted (L/s)
NT-1	Black Creek	Ikea Pond	1.0
NT-2	Black Creek	n/a	2.7
NT-3	Black Creek	UPS Pond	14.1*
NT-4	Hoover Creek	Tennis Canada Pond	28.2*
NT-5	Hoover Creek	Stong Pond	44.3
NT-6	Hoover Creek	n/a	16.3
NT-7/ST-3	Dufferin Creek	n/a	188.0
NT-8/ST-4	Black Creek	n/a	68.9
NT-9	Black Creek	Unnamed SWM Pond	6.9
NT-10	Black Creek	Black Creek Pioneer Village Pond	28.2*
ST-1	Black Creek	n/a	0.8
ST-2	Black Creek	n/a	1.4
407 Station – Point 1	Black Creek	n/a	16.8
407 Station - Point 2	Black Creek	n/a	16.8

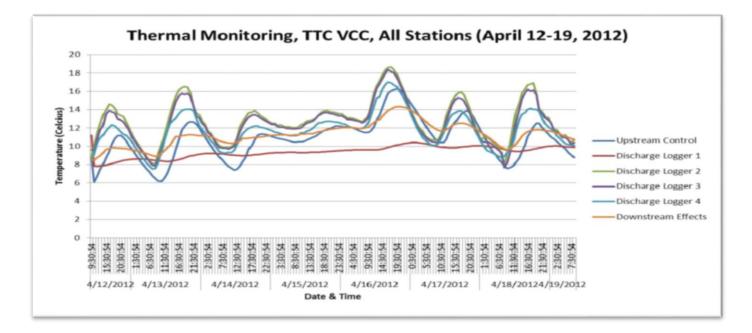
MONITORING: THERMAL IMPACTS

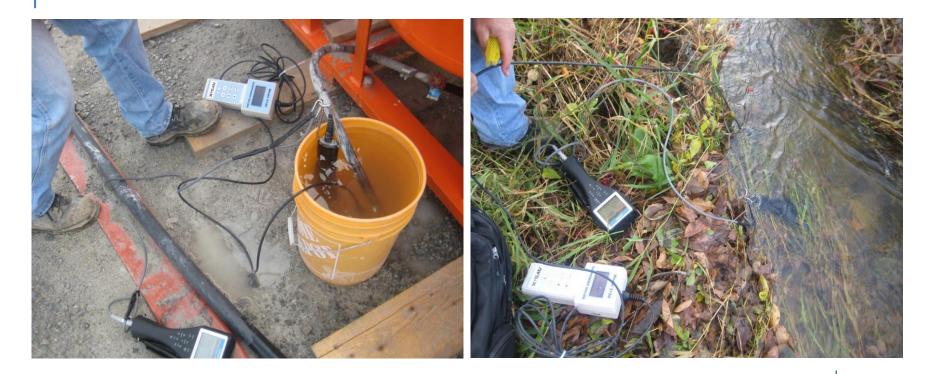
MONITORING: WATER QUALITY PARAMETERS

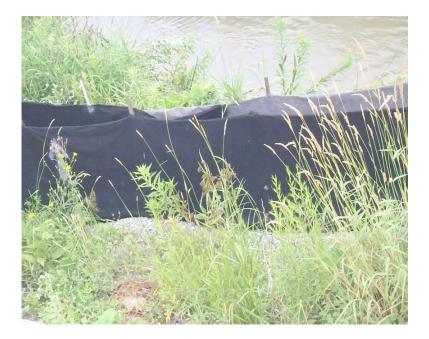
INSPECTING: EROSION AND SEDIMENT CONTROLS (ESCs)

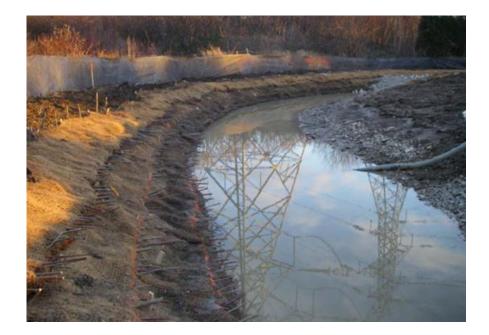
REALIGNED BLACK CREEK

Realigned to the east

- Obtained DFOs authorization under the *Fisheries* Act
- Built with Natural Channel Design Concept
- Implemented 5 Years Monitoring Plan
- Creek experienced significant lateral movement, erosion and bank failures multiple times
- Bank stabilization and valley land restoration still an issue
- Valuable infrastructure (station box, access bridge, pipeline) beside the creek

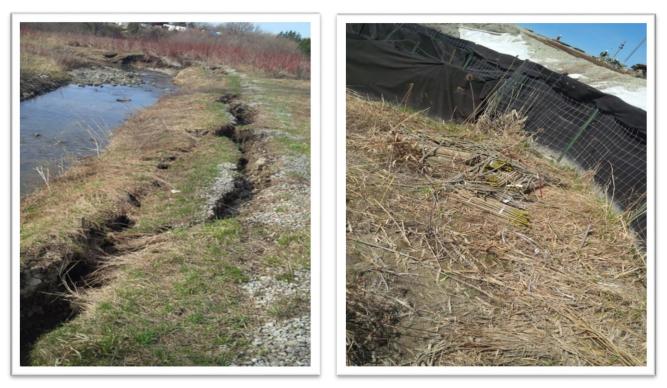
CREEK AND VALLEY LAND REHABILITATION- MULTIPLE BANK FAILURE

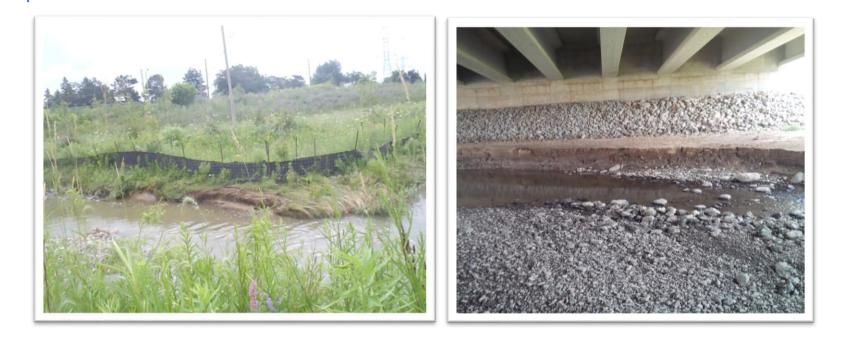
CREEK IS MOVING AND INFRASTRUCTURE IS AT RISK

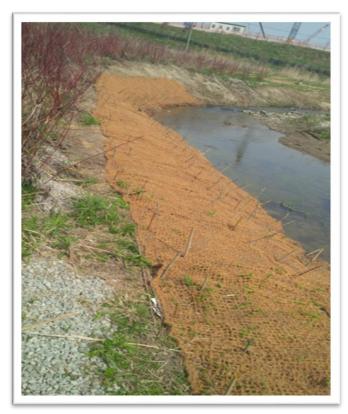
CREEK AND VALLEY LAND REHABILITATION
